WINTER MAINTENANCE

**Prepare your Cooling Tower for Summer
by Identifying and Replacing Worn or
Damaged Components**

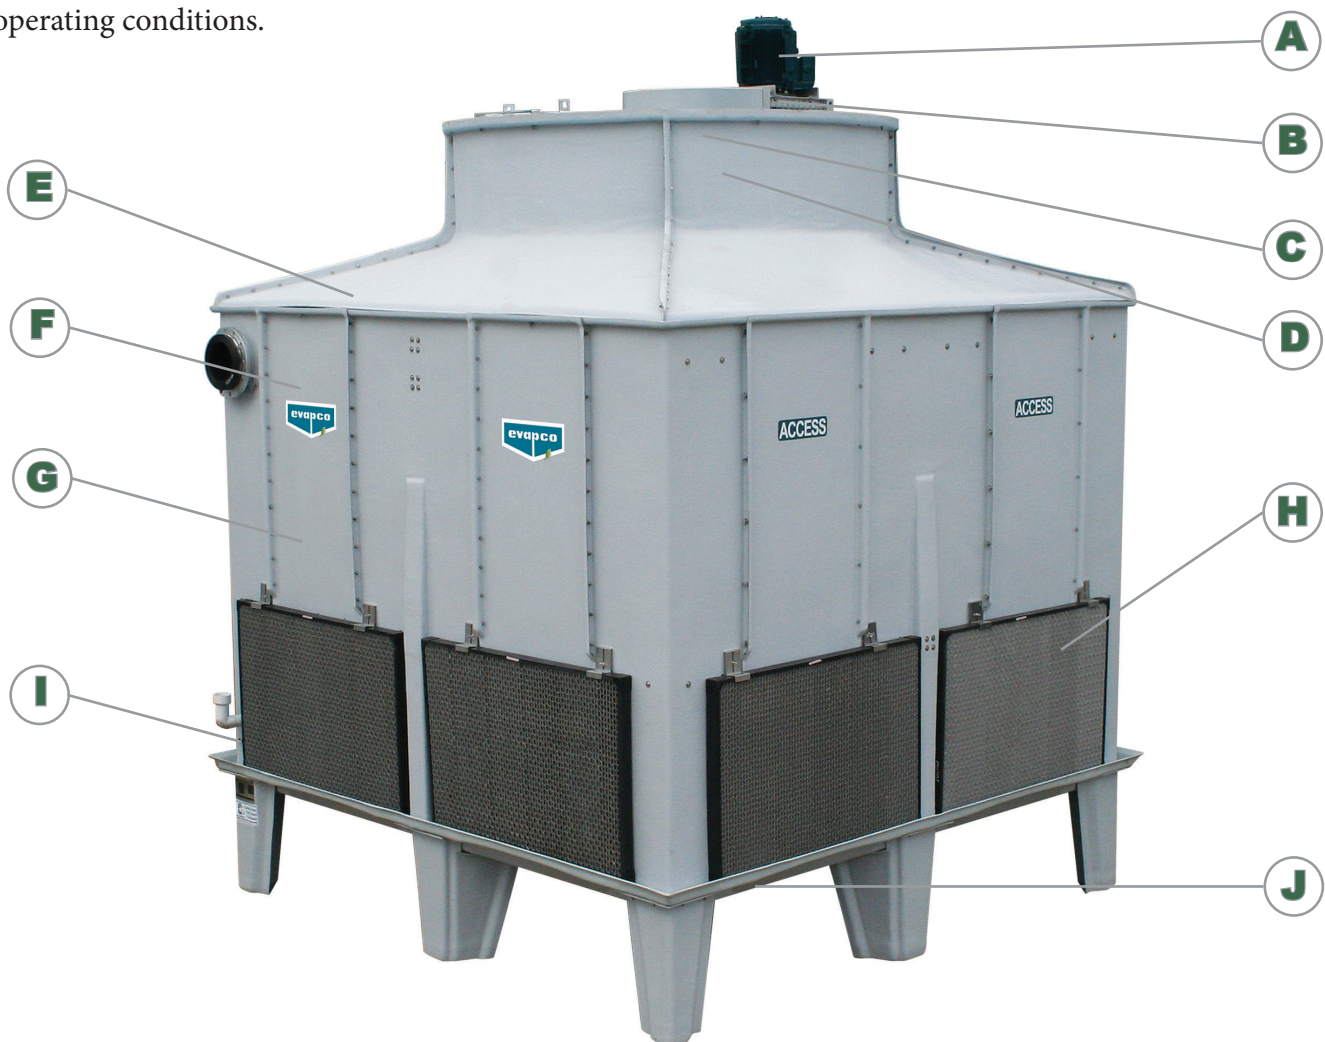
Although cooling towers are a critical component in the air conditioning system and for process cooling, they are often forgotten and / or neglected in terms of maintenance. Well maintained cooling towers ensure optimum system performance and reduced downtime. A proactive inspection regime shall include the components highlighted below, inspection frequency intervals shall be determined with consideration given to site specific operating conditions.

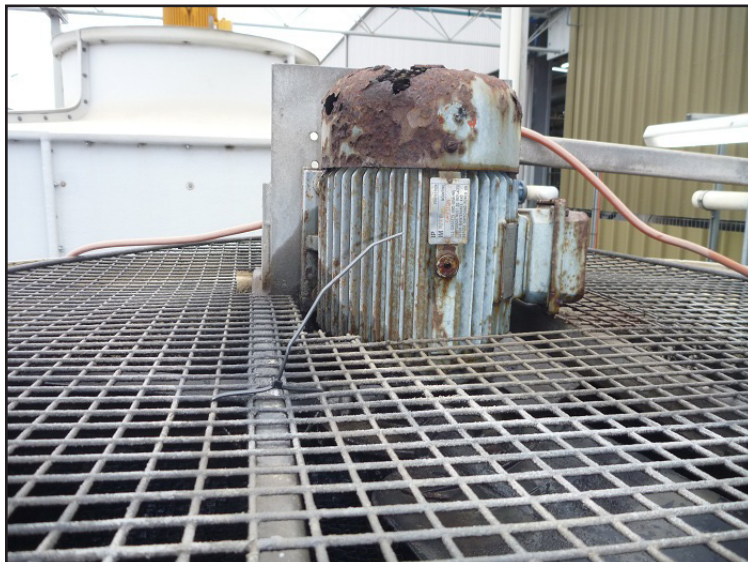
A Fan Motors

Fan motors are a critical component that should be regularly inspected and maintained. Fan motors can be located internal or external to the equipment depending on equipment brand and design. When inspecting fan motors look for common problems such as excessive motor housing corrosion, bearing wear and fan cowl corrosion. A proactive approach toward motor maintenance can reduce the chances of failure and afford owners the opportunity to replace older motors when convenient shutdown periods can be scheduled.

Isolate the motor and turn the fan by hand, check for any noise or vibration that may indicate the early signs of motor bearing failure.

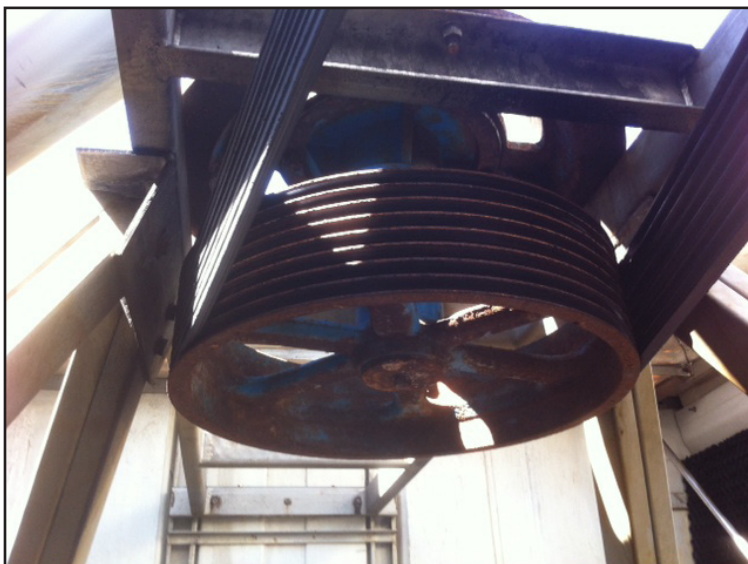
B Belts and Pulleys

The environment inside a cooling tower is very unforgiving for fan belts and pulley systems. Raw cast iron pulleys can exhibit signs of corrosion in a very short period of time leading to premature belt wear and significantly reducing belt life. Pulleys over time can also develop cracks in the hubs and spokes. It is important to check periodically for cracks in rotating equipment before the components fail and cause large scale equipment damage. EVAPCO Aluminium pulleys are resistant to corrosion and are the recommended upgrade for installations where premature belt wear is a continual problem.

Check pulleys for cracks.

Regularly inspect and replace corroded taper lock screws before they fail.

Corroded pulleys reduce belt life, Aluminium pulleys and banded belts can resolve this problem.

Maintain belt tension, loose belts can overheat and weaken, Do not over tension as this can damage shaft and motor bearings.

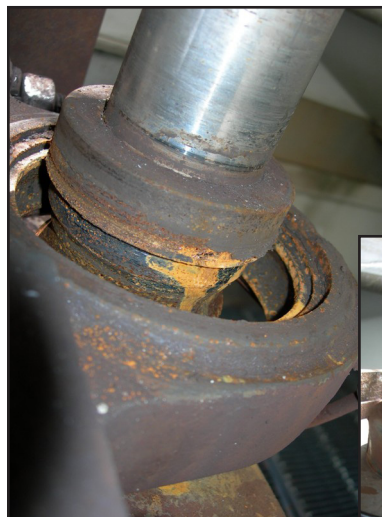
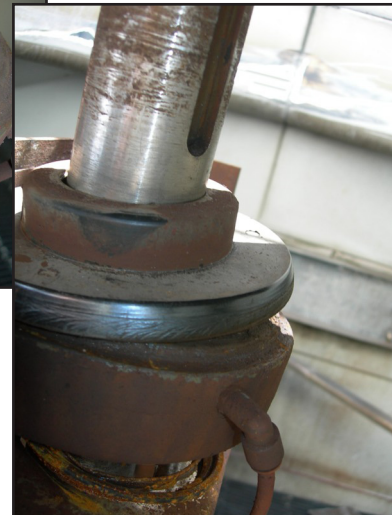
C Bearings

Cooling tower bearings are commonly subjected to overloading, fatigue failure, lubricant failure and corrosion. Internally mounted bearings are exposed to water drift, condensation and high temperatures which contribute to reduce bearing service life. To prolong bearing operation it is important that bearings are regularly inspected and greased.

When inspecting bearings it is important to remove the fan shaft belts to reduce the load on the bearings. Rotate the fan shaft and listen for any noises while checking for any vibration in the bearings. Noise or vibration are early warning signs of failure. If the equipment application is a critical process it is recommended that the installation site maintain an inventory of replacement fan bearings to reduce unit downtime should the bearings fail outside of planned replacement schedules.

If the unit has remote lubrication lines, check that they are not blocked and that lubricant is reaching the bearings. Vibration and Noise are the first warning signs of failure.

Bearing flingers help keep water out of the bearings and increase service life.

In winter it is important to operate the unit at least once a day to keep water from pooling in bearings.

Excessive belt tension can reduce bearing service life.

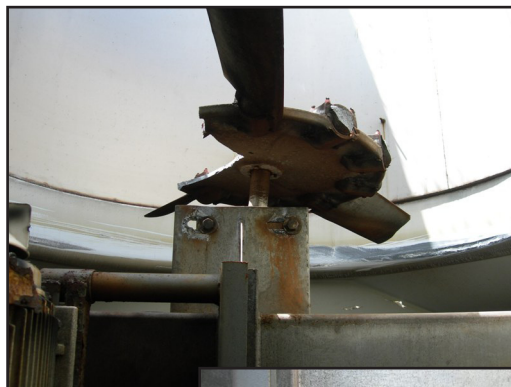
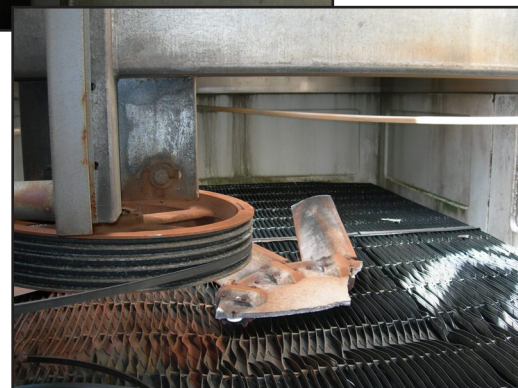
D Axial Fans

Axial fans drive a cooling tower's performance and are subject to extremely high stress during system operation. As a rotating "high speed" piece of equipment it is critical that fan components are regularly inspected for cracks, fatigue, corrosion and operational damage. If a fan failure occurs it can be extremely dangerous with the possibility that fragments of fan components could cause damage to external equipment or personal injury. Fan failures can also cause large amounts of damage internally to drift eliminators, fan cowls and distribution components. Periodical inspections of axial fans are essential and can identify the early stages of potential failure.

Check fan hubs and blades for cracks - if cracked replace immediately.

Replace corroded fan bolts and hardware to prevent failure.

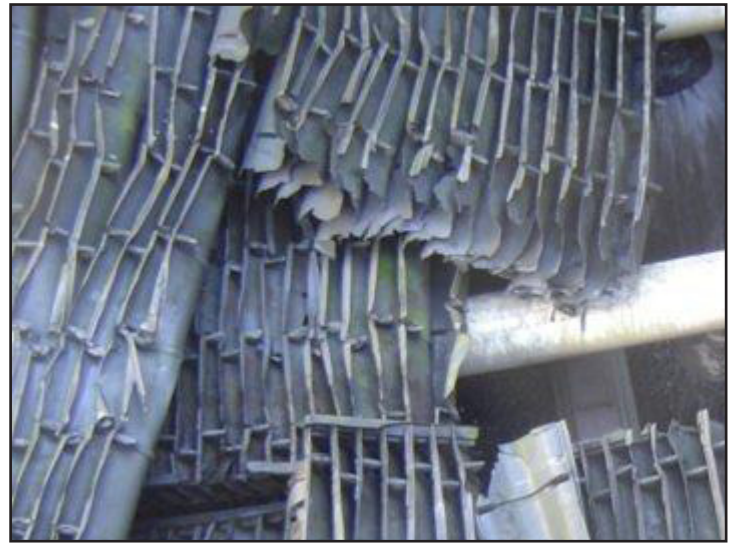
E Drift Eliminators

Drift eliminators are one of the most important components in a cooling tower they serve to reduce the drift loss of equipment. The higher the driftloss rating the less water and treatment chemicals will be lost through operational drift. Drift eliminators also eliminate sunlight from entering the tower which reduces algae and biofilm growth. It is important to inspect drift eliminators for any holes, cracks, gaps or blade damage. If the eliminators are damaged it is important to replace them immediately.

*Replacement drift eliminators must comply with the drift loss rate of 0.002% per AS3666.1 - 2011
EVAPCO EDE-001 drift eliminators are rated at 0.001% drift loss and can be easily retrofit to competitors equipment.*

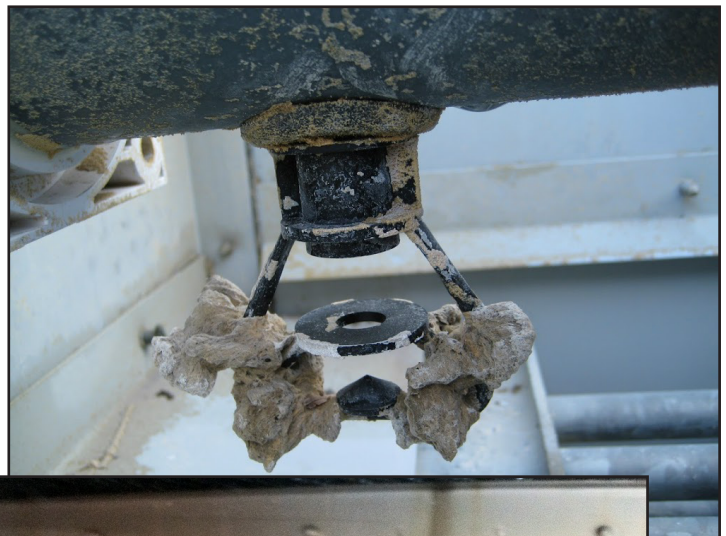
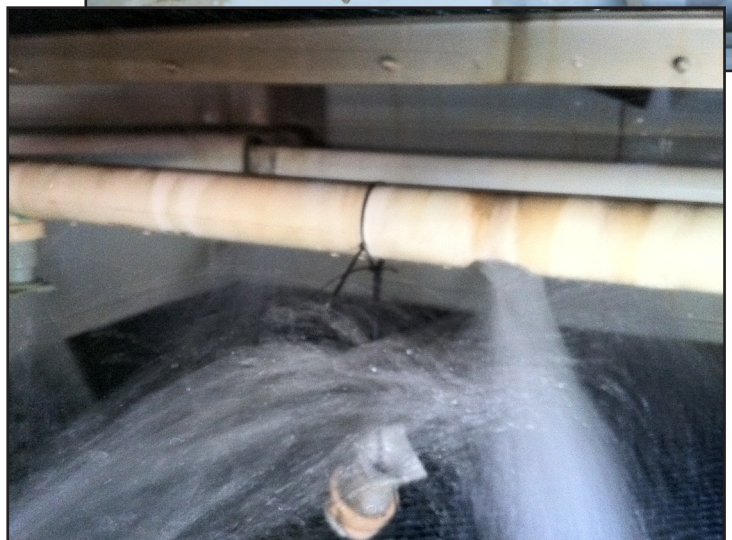
F Spray Nozzles

Spray nozzles should be regularly inspected to make sure they have not fallen out, become blocked or damaged. If the site water treatment regime is not working properly it can be common for nozzles to scale up and block, which can result in a loss of equipment performance. Blocked nozzles or scaled nozzles can also change the characteristics of the spray pattern of the nozzle which can translate into dry spots on the fill which can lead to the fill scaling up and loss of heat rejection capability. Severely blocked nozzles can cause line pressures within the branch arms to increase to a level where nozzles can dislodge from the branch arm thread or grommet sending un-diffused high pressure jets of water directly into the PVC fill pack. The jet of water can be powerful enough to cut a hole straight through the fill which leads to water bypass and loss of heat rejection capability. If this happens the fill blocks will need to be replaced.

Blocked nozzles can lead to costly fill block damage and loss of unit performance.

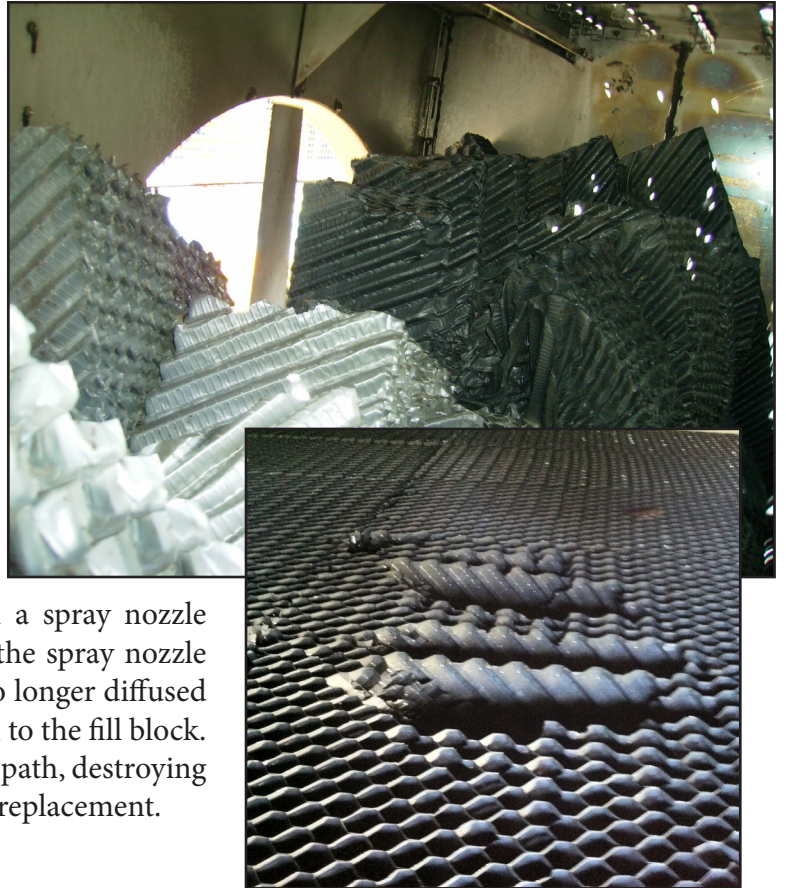
G Fill Blocks

Cooling towers are very efficient at scrubbing air drawn in from the surrounding environment. Scrubbed airborne particles become suspended in the cooling tower re circulating water and can accumulate in the cooling tower fill flutes, blocking the fill and adding significant weight to the fill and fill support system. Severely blocked or scaled fill can lead to fill support failure and a costly repair bill. Industrial and mining sites are more susceptible to fill clogging and should schedule inspections of the fill to avoid problems.

It is also common for fill to become damaged when a spray nozzle becomes dislodged from the spray branch arm. With the spray nozzle missing the high pressure water in the branch arm is no longer diffused allowing a high pressure jet of water to spray directly on to the fill block. The water jet can cut a hole through all layers of fill in its path, destroying the fill - leading to unit performance loss and costly fill replacement.

Scaled or blocked fill can cause fill supports to collapse and damage to the cooling tower casing. Fill blocked with contaminants or scale should be replaced to prevent fill support failure and restore thermal performance.

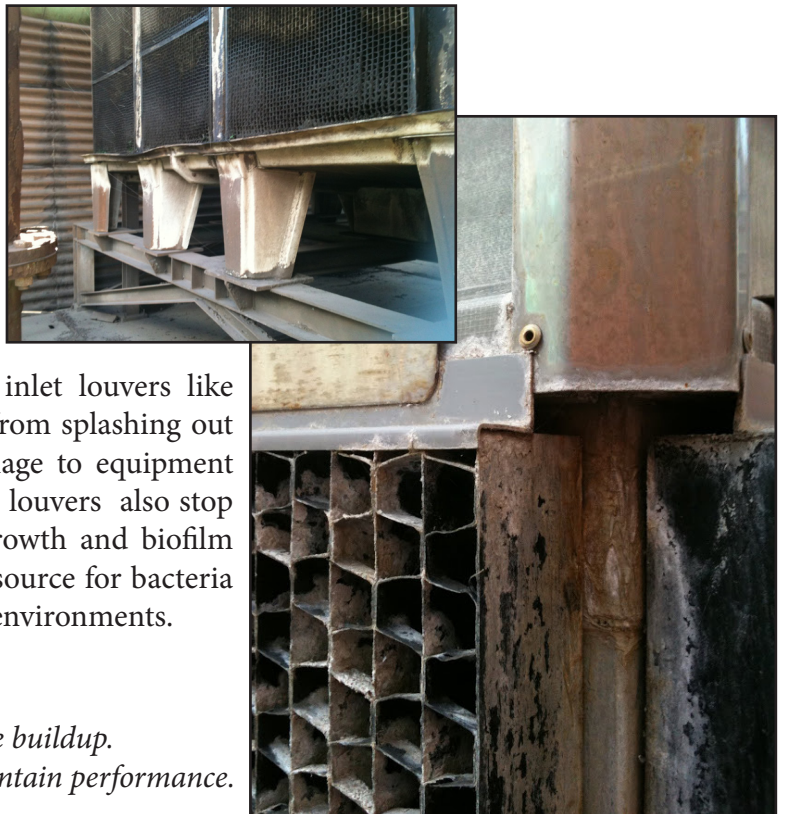
H Inlet Louvers

Inlet louvers are easy to inspect and clean and can usually be easily removed from the cooling tower without the use of tools. Inlet louvers stop water from splashing out of the cooling towers rain zone and stop

sunlight exposure of the basin water. High quality inlet louvers like EVAPCO's WST stop water and expensive chemicals from splashing out of the tower, which if left unchecked can cause damage to equipment and pipework external to the cooling tower. WST inlet louvers also stop sunlight from penetrating the basin limiting algae growth and biofilm development. Algae and biofilms are a common food source for bacteria and can assist the sustainability of bacteria supporting environments.

Inlet louvers should be cleaned as required to reduce scale buildup. Replace inlet louvers that are cracked or damaged to maintain performance.

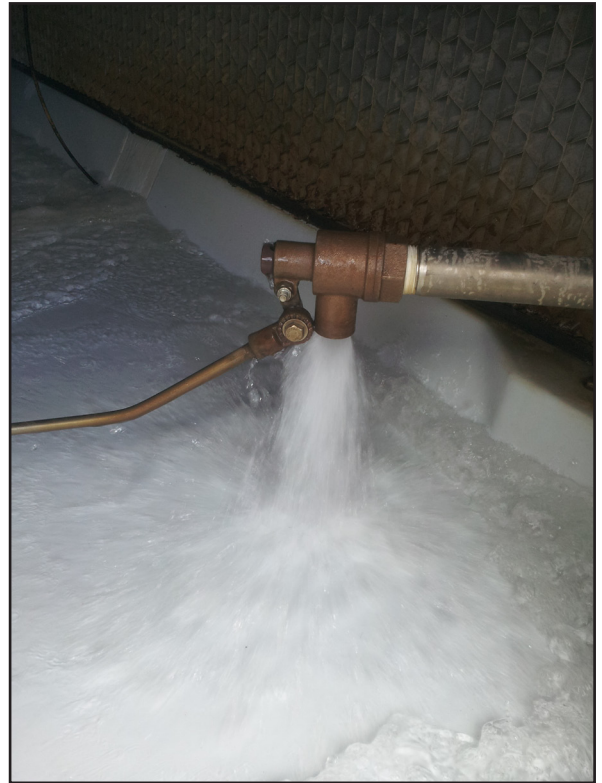
I Make-Up Valve

Water within the cooling tower is continually removed from the system via evaporation, drift and bleed. The mechanical make-up valve returns fresh water to the system preventing the system from running dry.

The make-up valve should be inspected regularly and adjusted as needed to maintain the correct operating water level. During inspection ensure the valve can open and close freely. If the make up valve sticks closed the system can run dry, if the make up valve sticks open fresh water will be lost to overflow.

A float valve that releases water when closed indicates the rubber seal inside is damaged and the seal or the entire valve needs to be replaced.

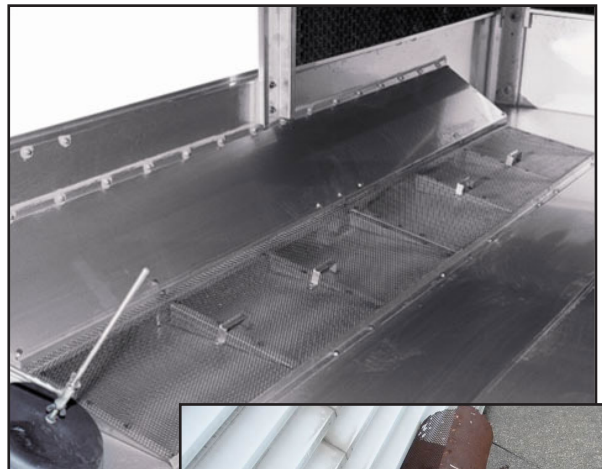
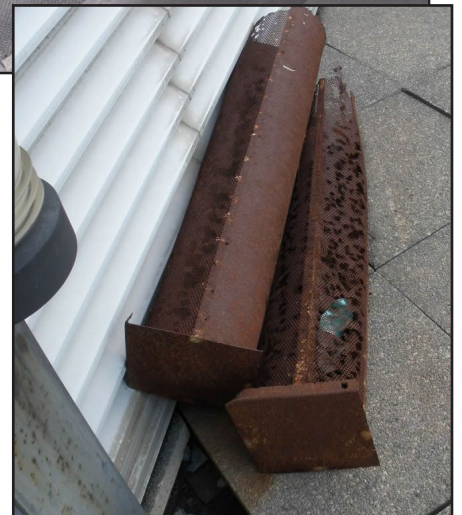
J Strainer

Cooling tower strainers are designed to keep large debris from being drawn into downstream strainers or pumps. Strainers should be checked regularly to make sure they are not blocked or displaced from the suction opening. Many competitors cooling towers utilize galvanized suction strainers that can corrode allowing corroded pieces of the strainer to be drawn into the pipe system. Corroded or damaged strainers should be replaced to prevent a reduction in water flow or damage to downstream equipment.

Corroded strainers can break apart and damage down stream equipment. Strainers are the first line of defence in keeping debris out of the system.

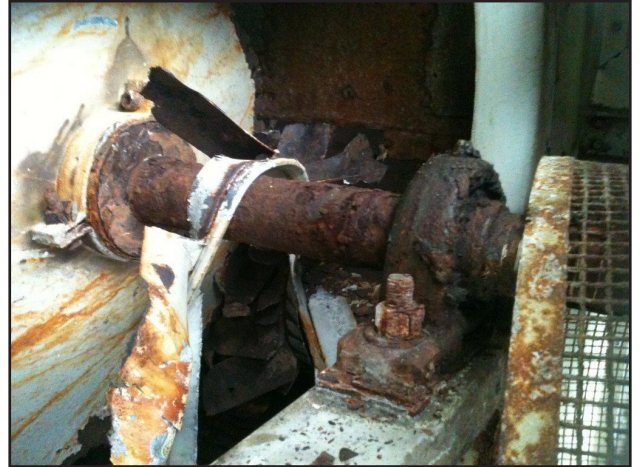
Centrifugal Fan Wheels

Centrifugal fan wheels are utilized in forced draft equipment and are commonly manufactured from galvanized steel, or epoxy painted steel. Centrifugal wheels are exposed to water spray and humid condensation. Without maintenance galvanized and epoxy painted wheels will eventually develop rust and the blades could fail causing the wheel to break apart. Mr. GoodTower® can supply and install stainless steel fan wheels that meet or exceed competitors unit requirements and will last the lifetime of the equipment.

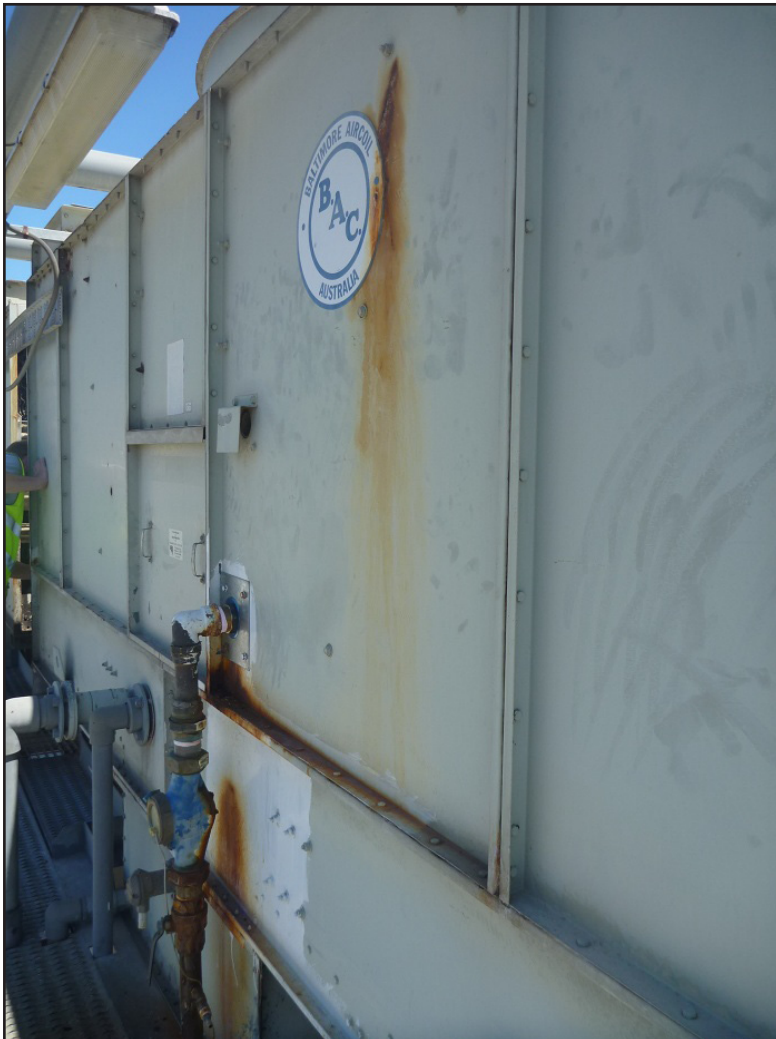
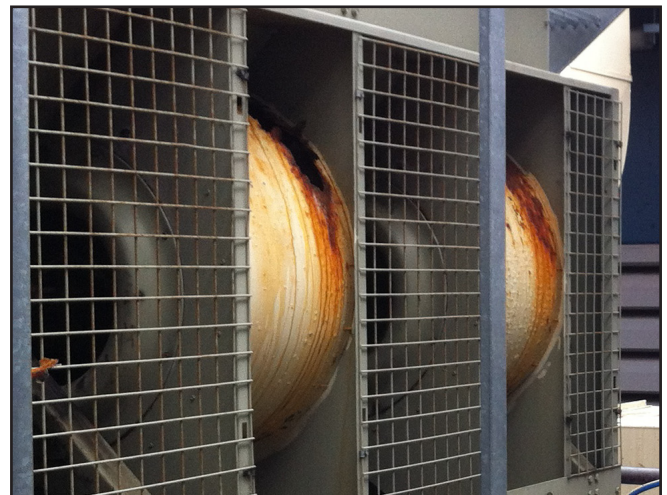
Corroded Panels

Inspect steel equipment panels inside and out for signs of corrosion. It is common for steel force draft equipment to corrode at the fan wheel housings and internal snouts, if corrosion is found on these components it should be treated and repaired immediately before leaks or damage to the fan wheel occurs. Check between the fill and casing panels on crossflow steel cooling towers as this is often a common location for rust to develop.

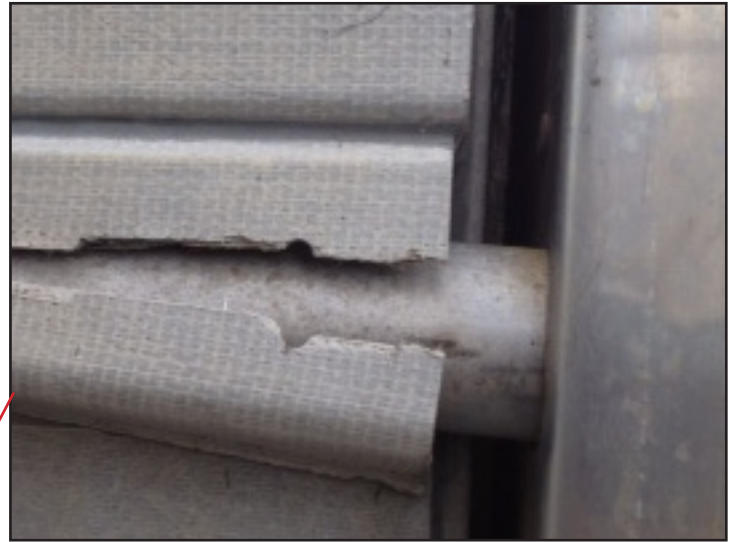
Cracked casing panel on competitors RCT cooling tower.

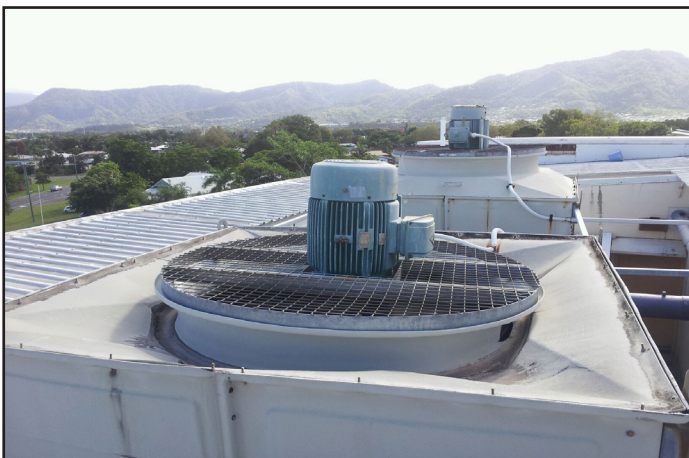
Collapsed fibreglass fan cylinder on competitors IL cooling tower.

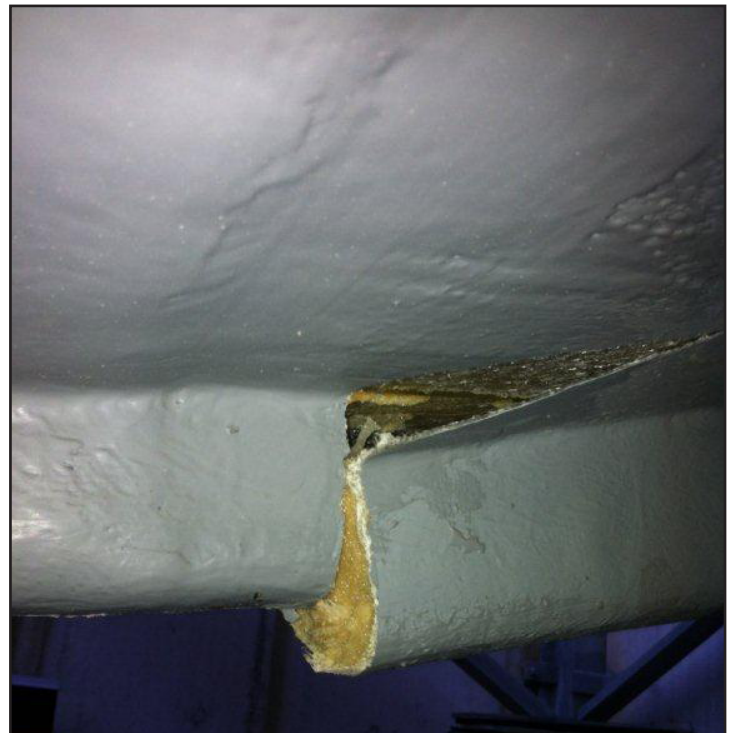
Cracked basin on RCT cooling tower.

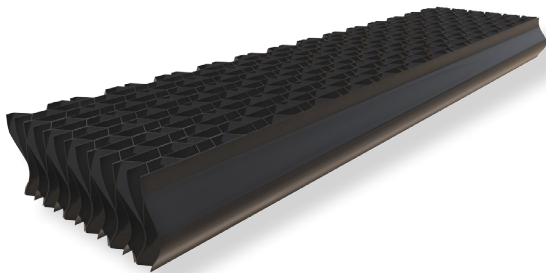
EDE-001 Drift eliminators exceed the requirements of Australian Standards. Mr. GoodTower can supply cut to any dimensions
